USCG FY2006 Grant
In-Water Shock Hazard Mitigation Strategies
Final Report October 1, 2008

Authored by James D. Shafer and Capt. David E. Rifkin (USN, Ret)

USCG FY2006 Grant
In-Water Shock Hazard Mitigation Strategies

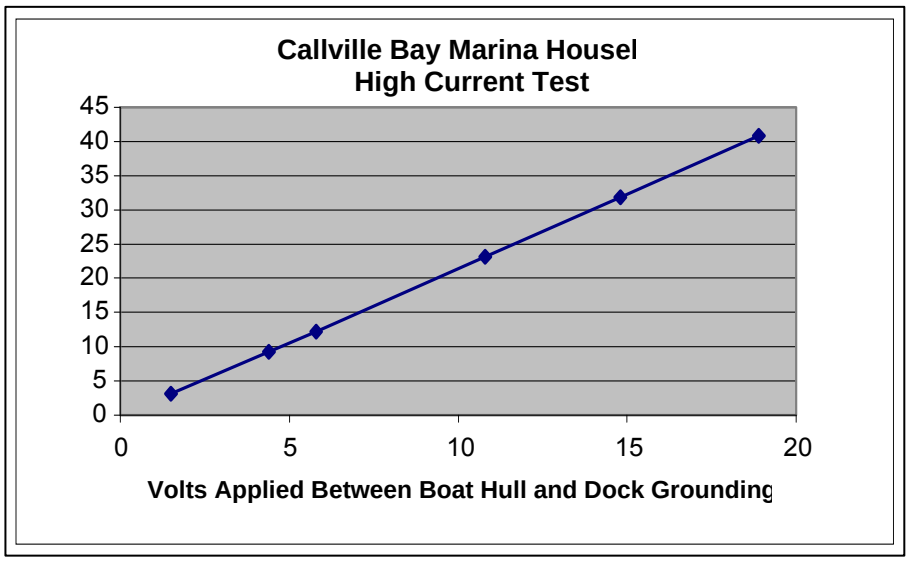
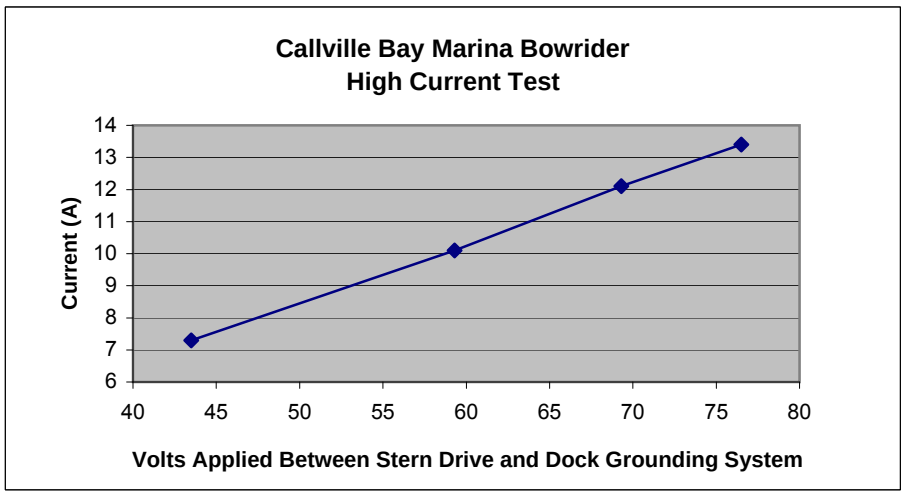
Calville Bay Marina, 4/11/07. Voltage was applied to the hull (top) and outdrive (bottom) and the resultin water current measured.
Four electric hair dryers were used as ballast to prevent an uncontrolled overcurrent situation.
Using the linear relationship between voltage and current, the current for any voltage can be extrapolate

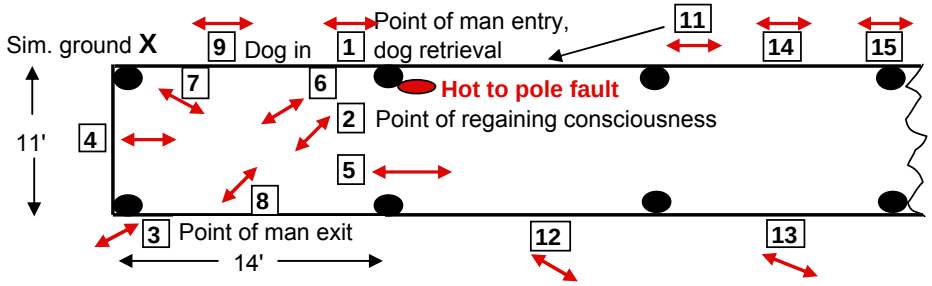
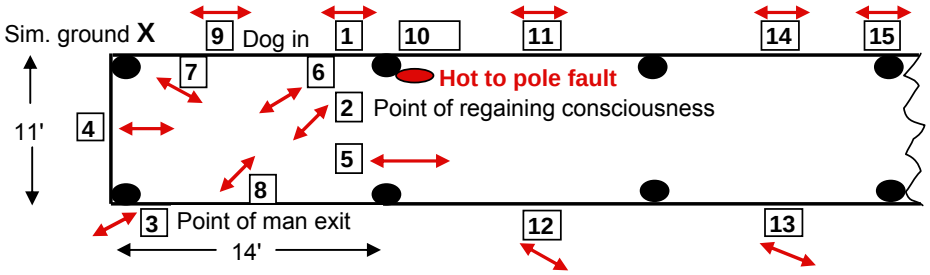
This test recreated a near miss electric shock drowning event at a private residence in Grand Island, NY. The electrical conditions had not been altered since the accident in September of 2000 on the Niagra River a few miles upstream from the Falls. Two boats were present at the time of the accident and were not available for the recreation. A simulated grounding plate was used to determine the extent of the affect of the 2 boats. A romex-encased lighting conductor wore through the insulation and came in contact with a round steel pile supporting the dock. It may have welded itself to the pile causing a direct fault to the earth. The pile was not connected to the bonding system of the electrical service.

The data represent worst case voltage gradients since we did not know how good a connection the fault was making at the time of the accident. The owner was not wearing any type of rubber insulation suit.

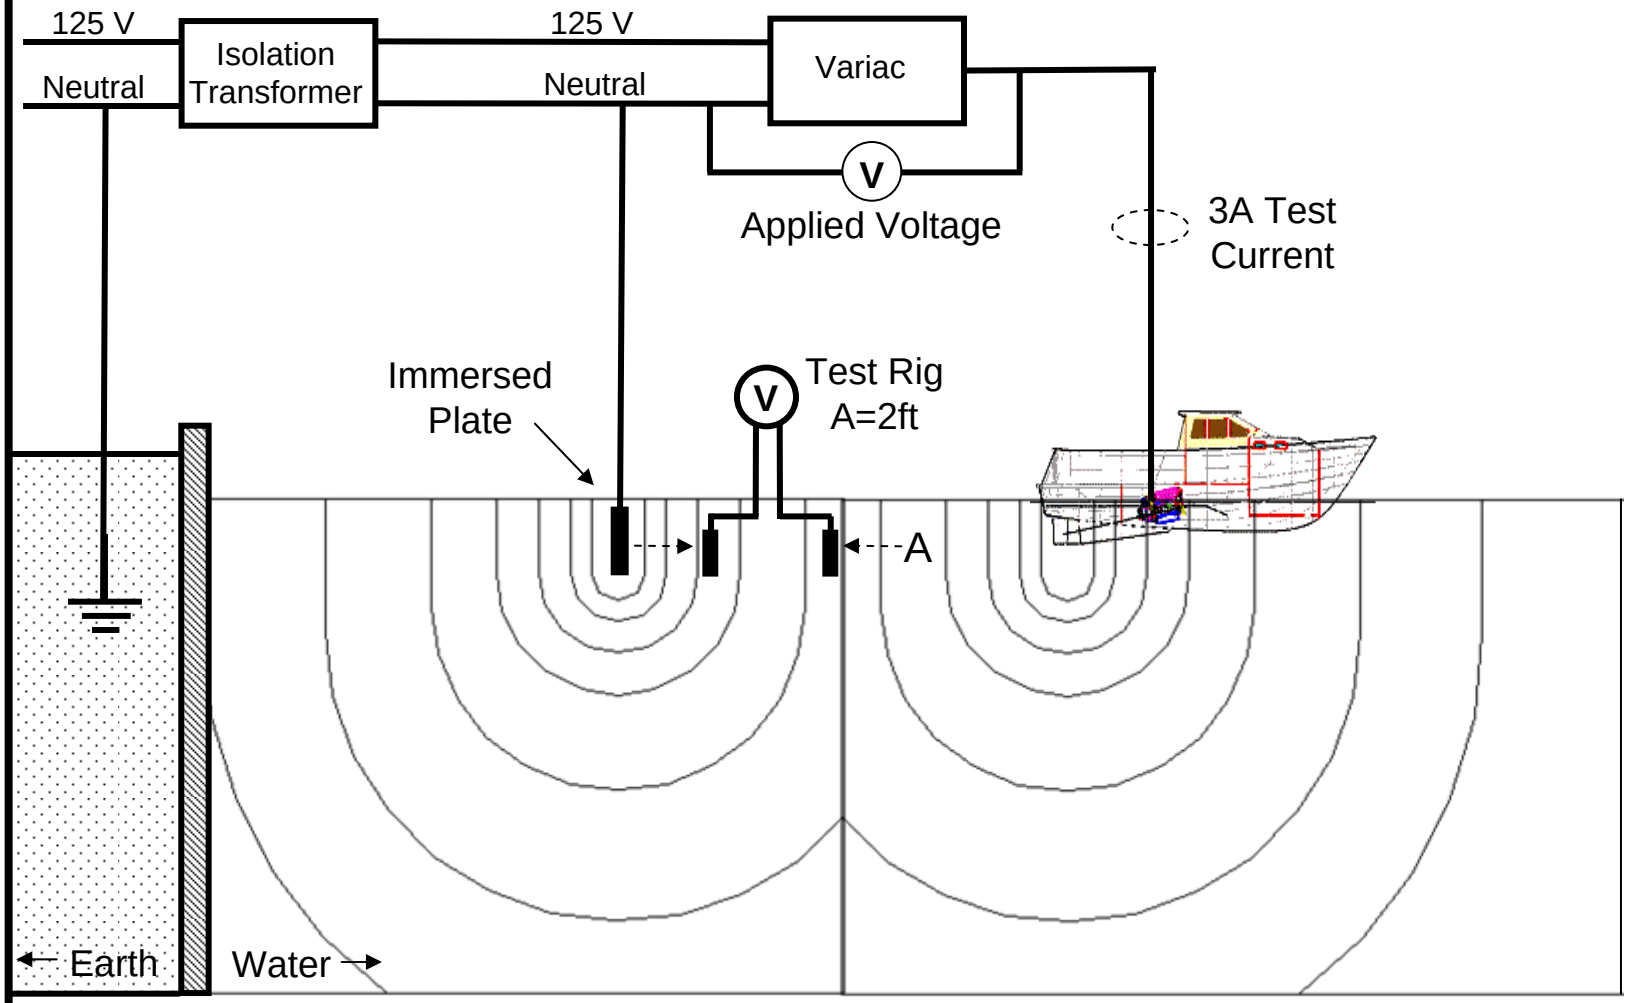
Drawing 3
See 1.E.vi of Test Procedure

Constant voltage applied for 3A test current into bonding (grounding) system; voltage gradient at plate measured (isolated ground)

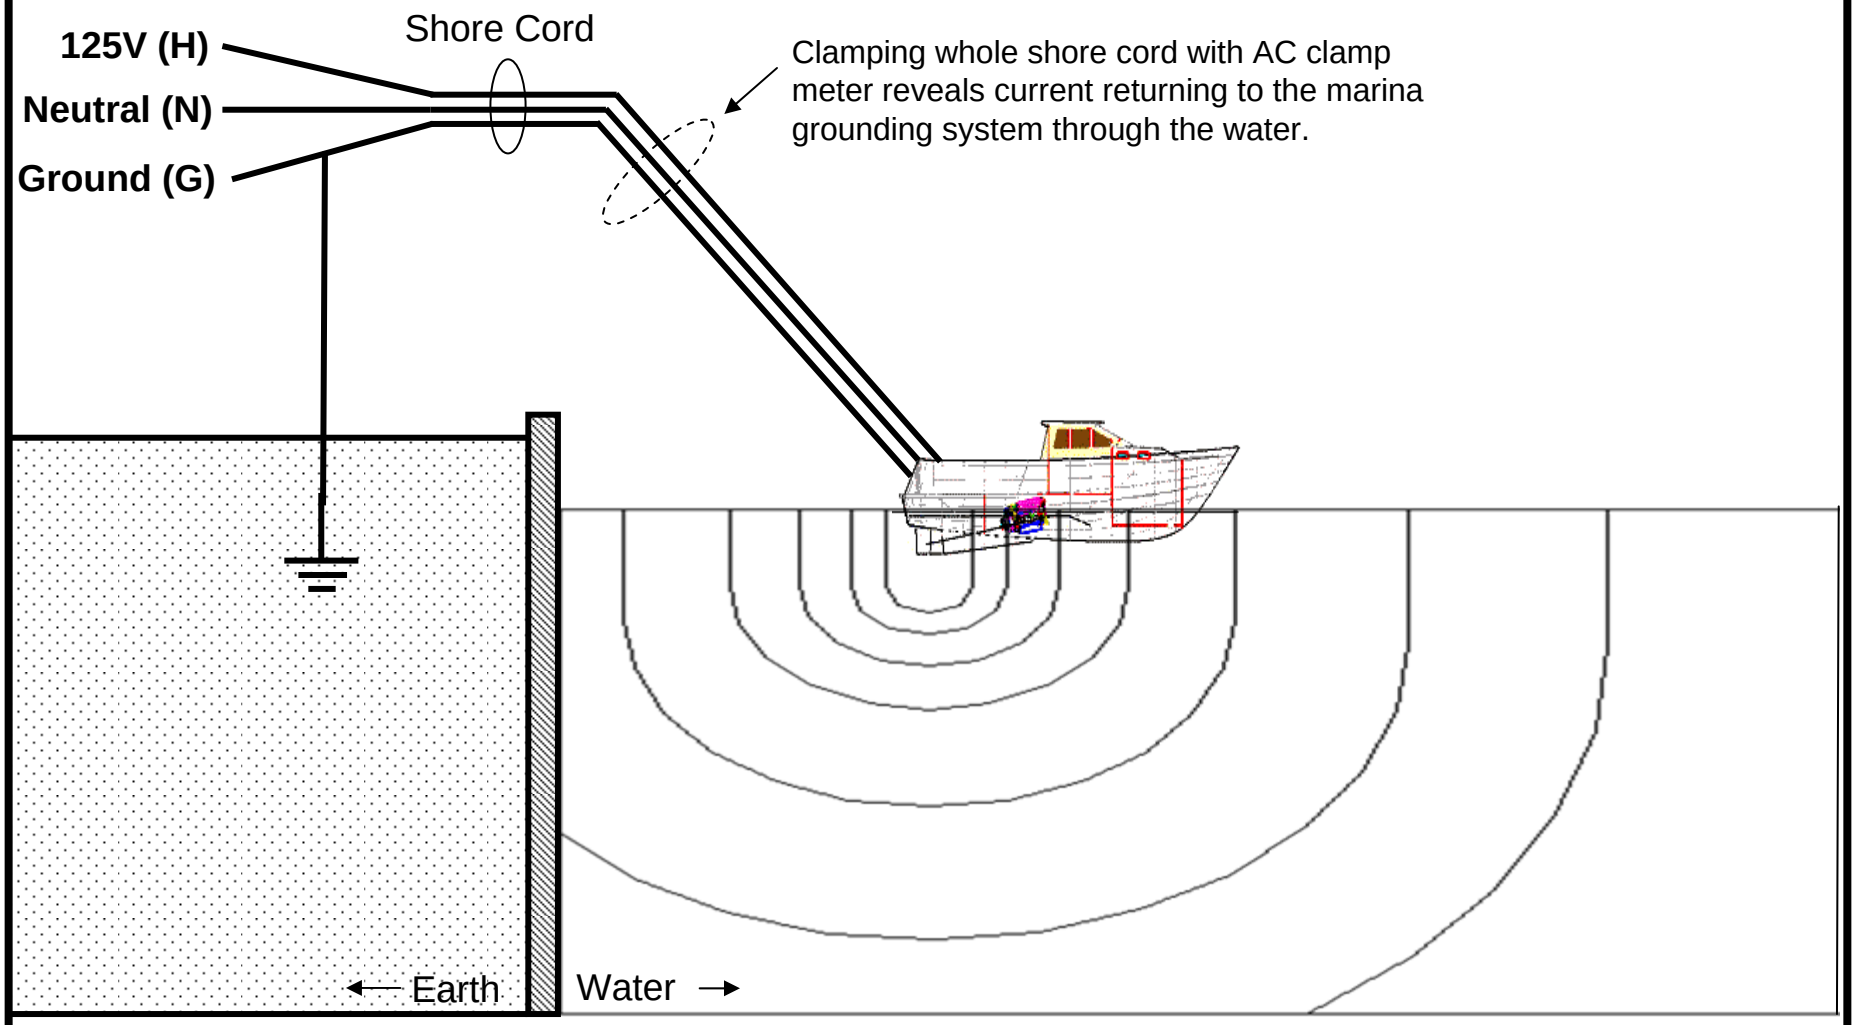
Drawing 4
See 1.E.vii of Test Procedure

AC Leakage Test

AC shore power on and loads running; current leaking into the water measured

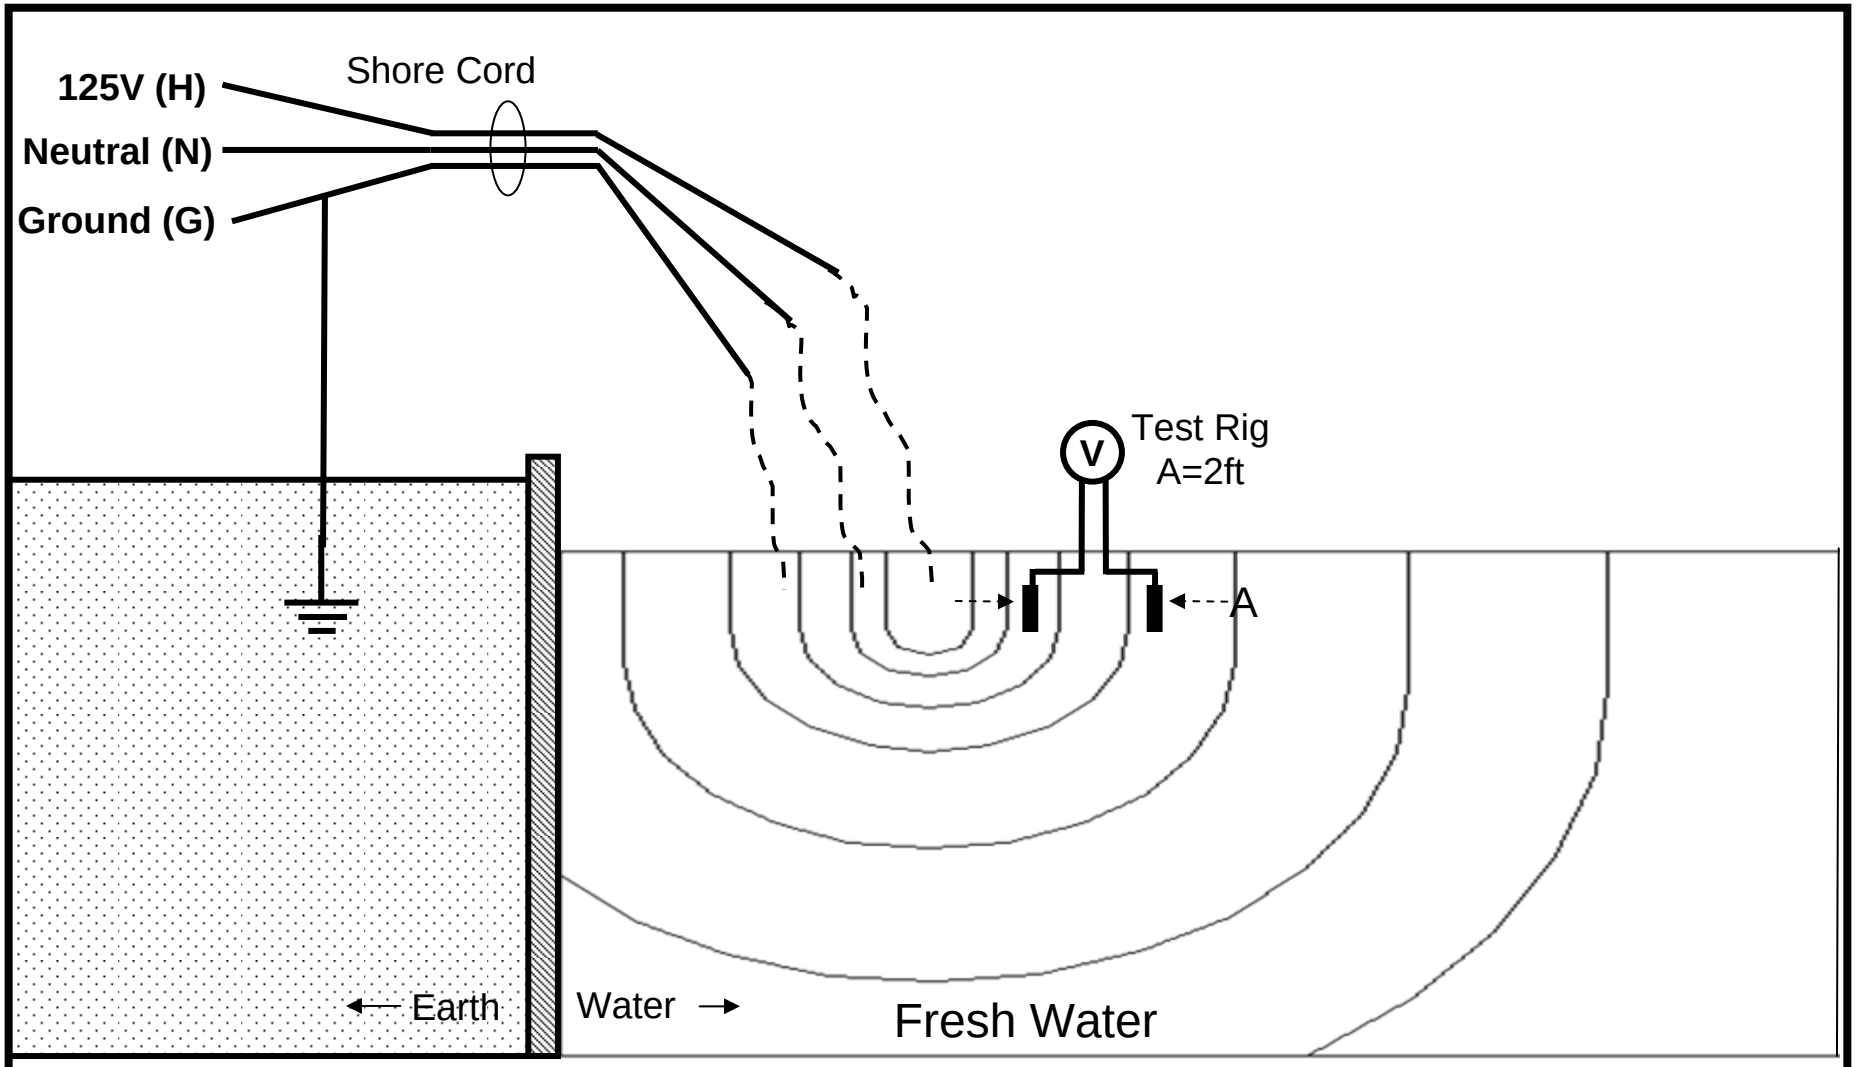
Drawing 6
See 1.E.ix of Test Procedure

Broken Cable Insulation Test
